The septic application process: an Onkaparinga perspective

**Waste Water Management Seminar
Murray Bridge
October 21 – 23, 2003**

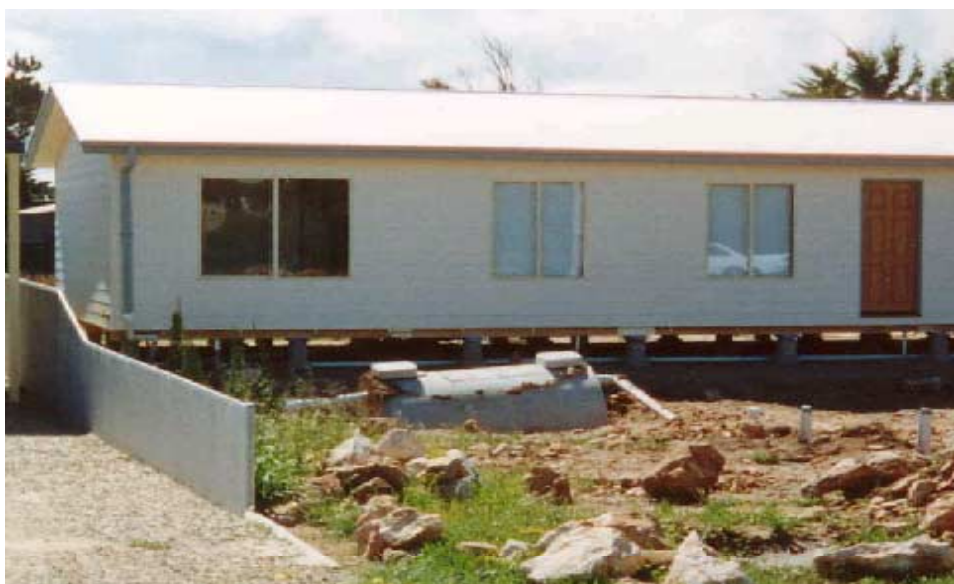
Take note: Concrete tanks can float!

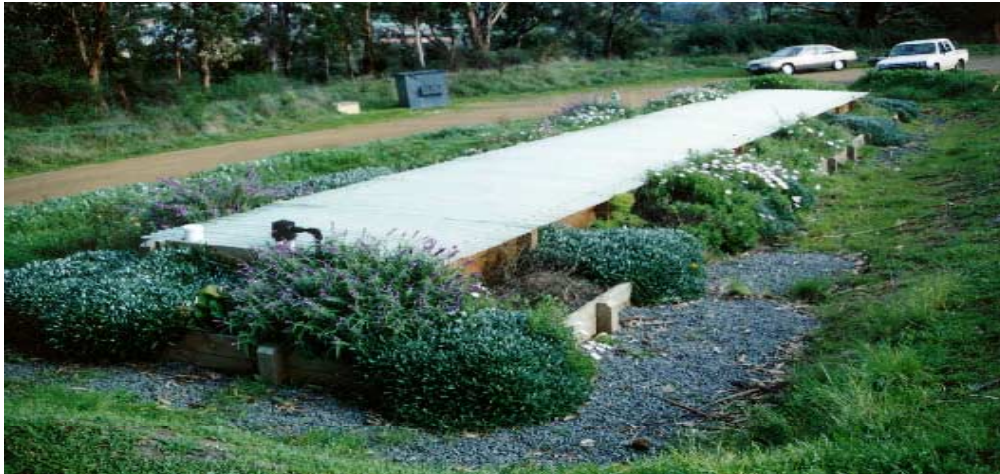
*Photo: Above ground Modified Adsorption Trench (elevated)-MAT(E)
Kingston Golf Course, Tasmania*
